FINAL REPORT

EVALUATION OF WORN SSME LOW PRESSURE
LIQUID OXYGEN TURBOPUMP BEARING

Contract No. NAS8-33576

BATTELLE
COLUMBUS LABORATORIES
505 KING AVENUE
COLUMBUS, OHIO 43201

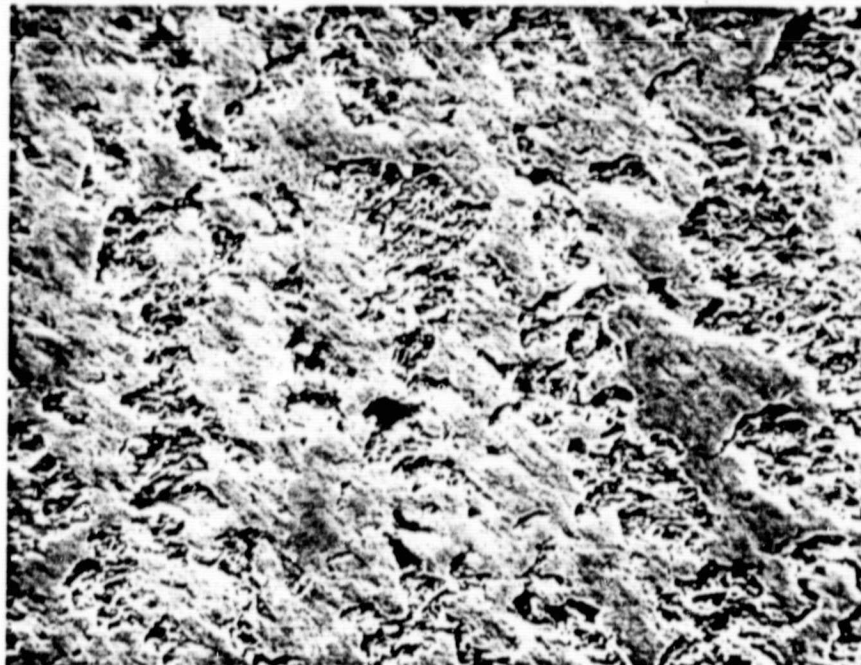
FIGURE 2. SCANNING ELECTRON MICROGRAPHS OF WEAR
TRACKS ON INNER RACEREPRODUCIBILITY OF THE
ORIGINAL PAGE IS POOR

Examination of the worn races in the SEM showed the wear to be fairly uniform across the widths of the individual ball-contact paths. The wear patterns consisted of numerous pitted areas separated by raised featureless areas which apparently had been in contact with the balls. Typical areas are shown in Figures 2 and 3. The wear was most severe on the inner races tracks, while the high-angle track on the outer race was least severe. Neither race contained any major pits, gouges, or dents, rather they showed the results of a mild and gradual wear process.

a. High contact-angle track

b. Low contact-angle track
